# PERFORMANCE OF GEOTEXTILE SEPARATORS, BUCODA TEST SITE – PHASE II

WA-RD 440.1

Final Report  
July 1997

**Washington State  
Department of Transportation**

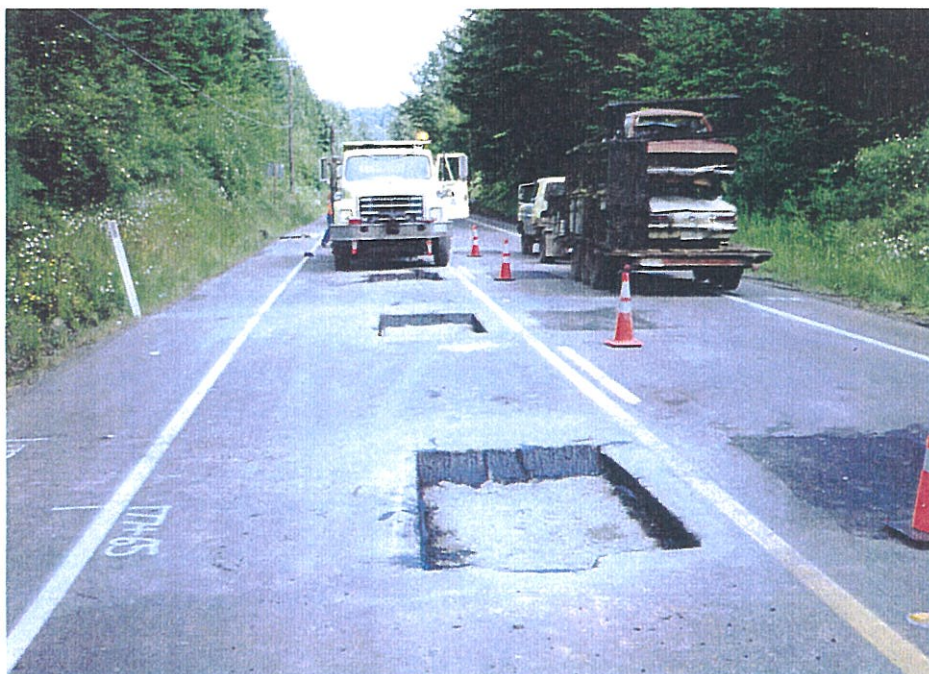
Figure 5.4 - Patching operations.

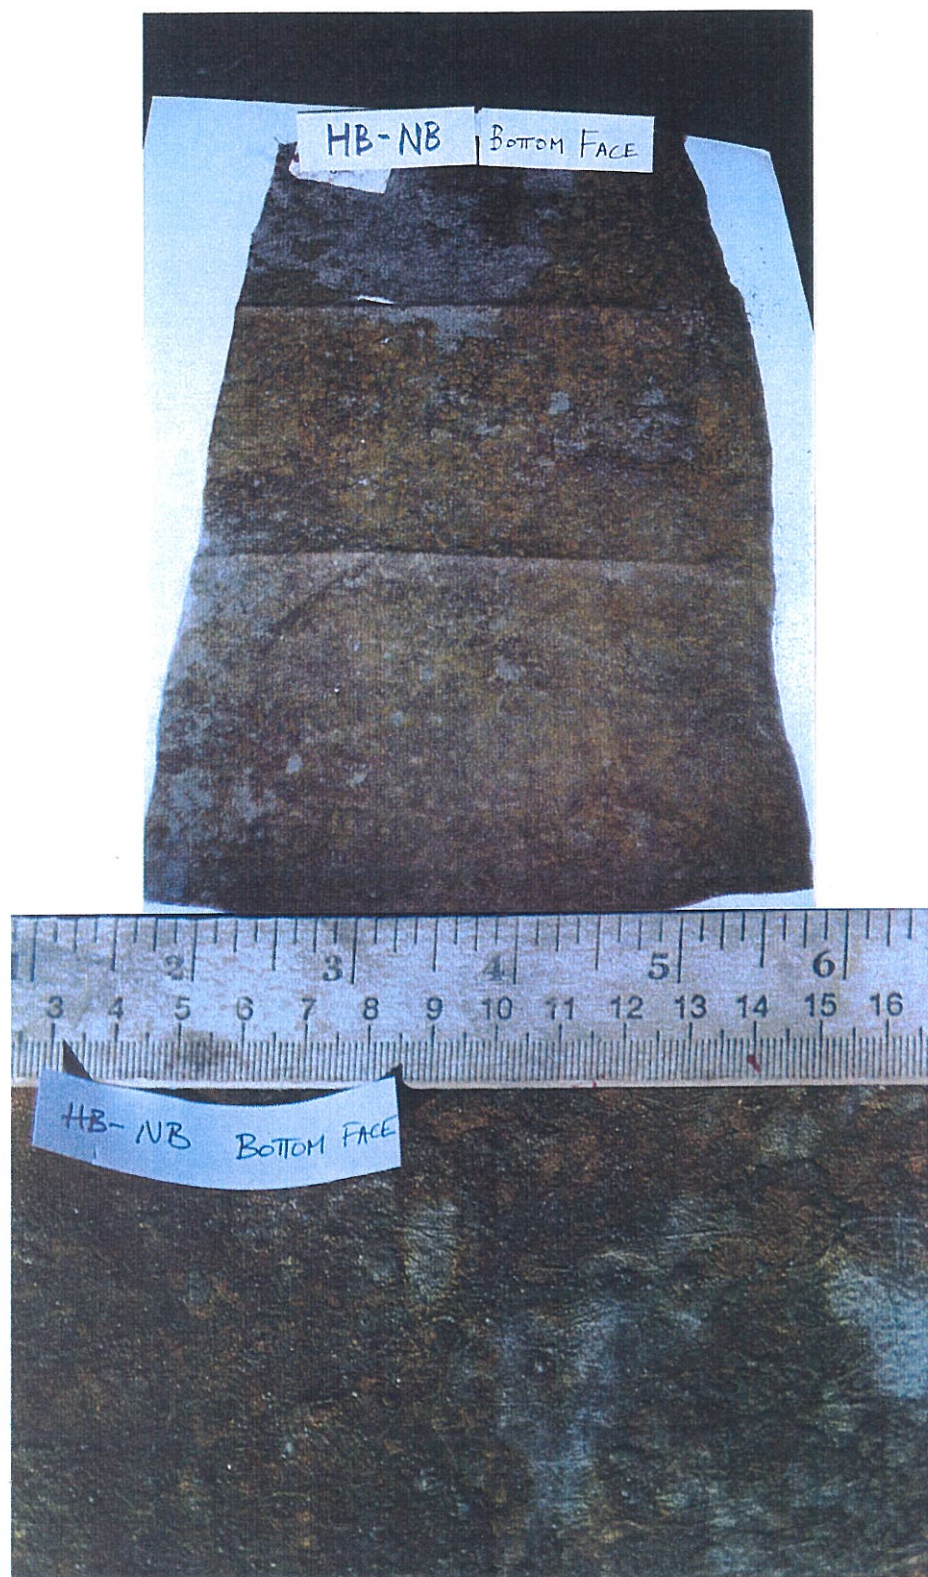
Figure 5.8 (top) - Bottom face of HB-NB, laboratory photograph. Figure 5.9 (bottom) - Bottom face of HB-NB, laboratory photograph showing iron staining.

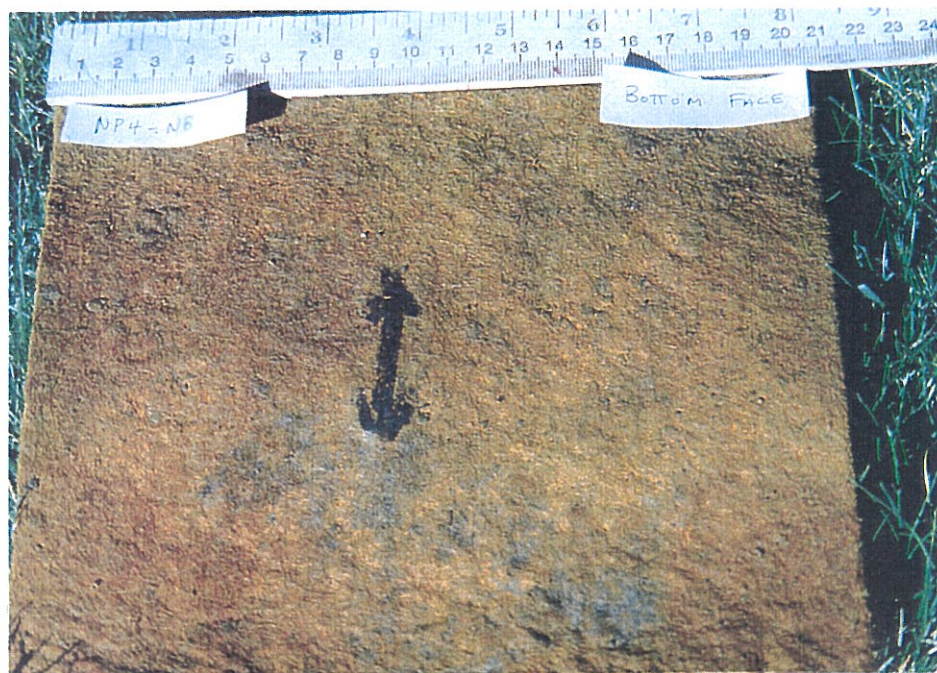
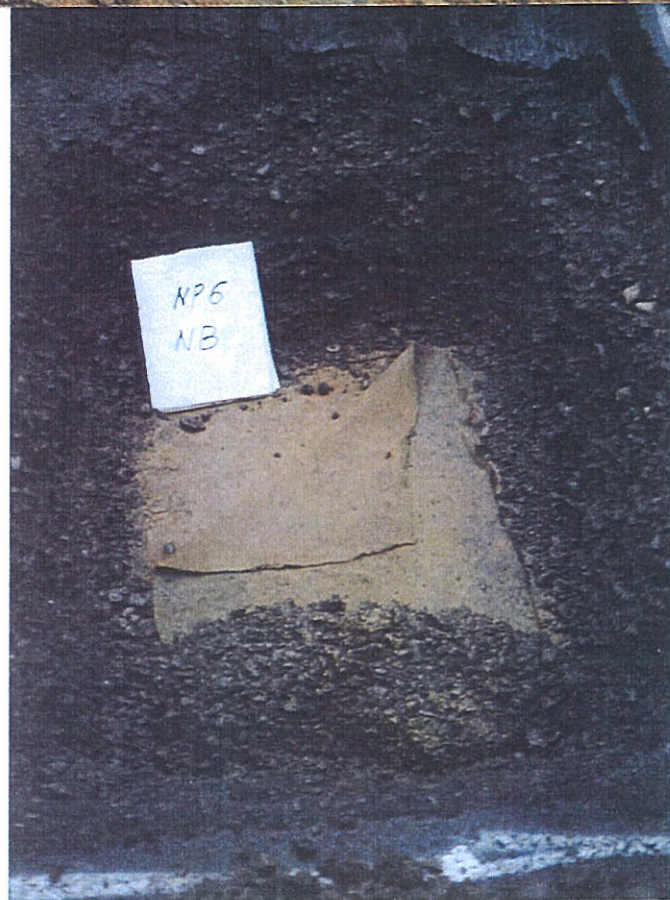
Figure 5.12 (top) - Bottom of NP4-NB wide width specimen, lab. photo. showing iron staining. Arrow indicates machine direction. Figure 5.13 (bottom) - NP6-NB geotextile before removal, with corner peeled back.

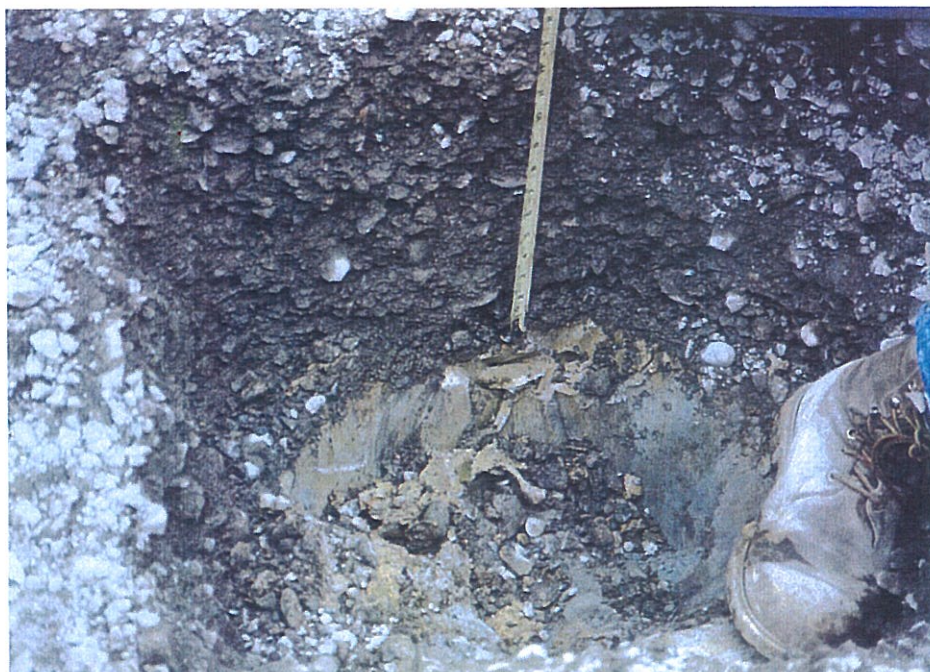
Figure 5.15 - Soil-NB section interface between base course and subgrade soils.

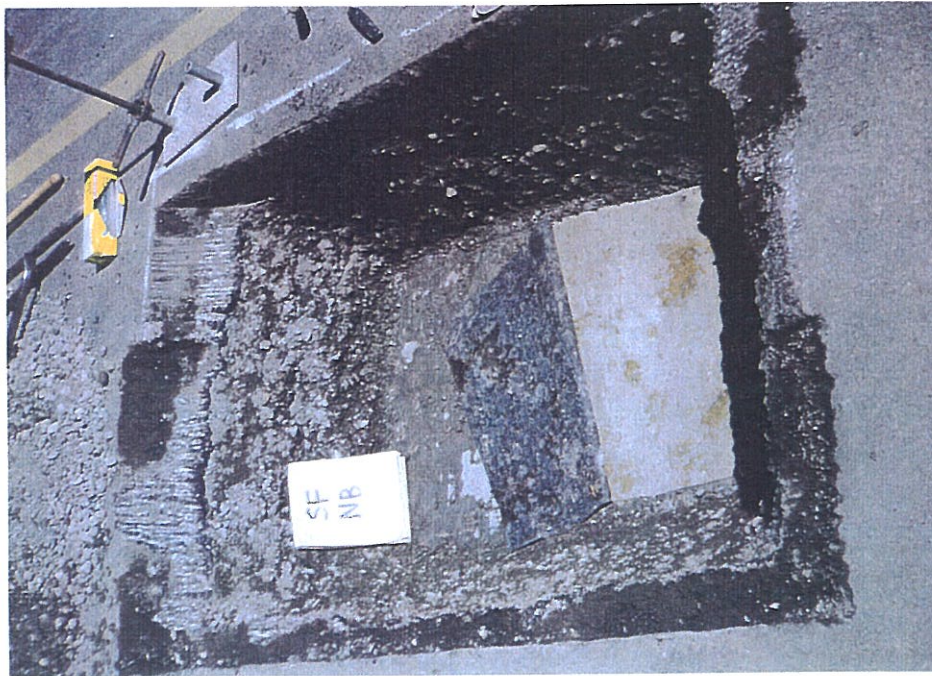
Figure 5.20 - SF-NB geotextile before removal, with corner peeled back.

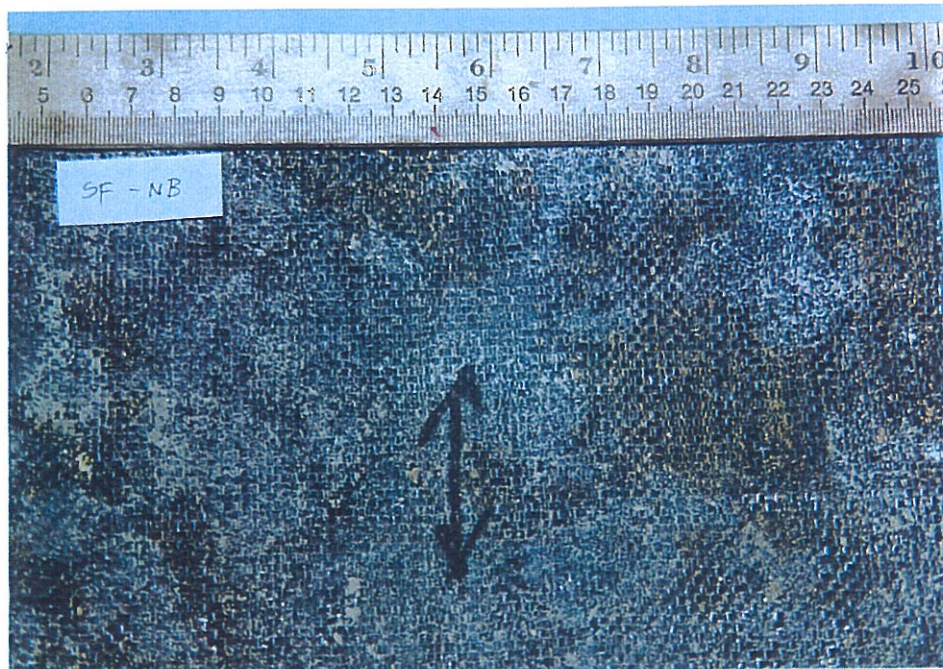
Figure 5.22 - Bottom of SF-NB wide width specimen, lab. photo. showing iron staining. Arrow indicates machine direction.

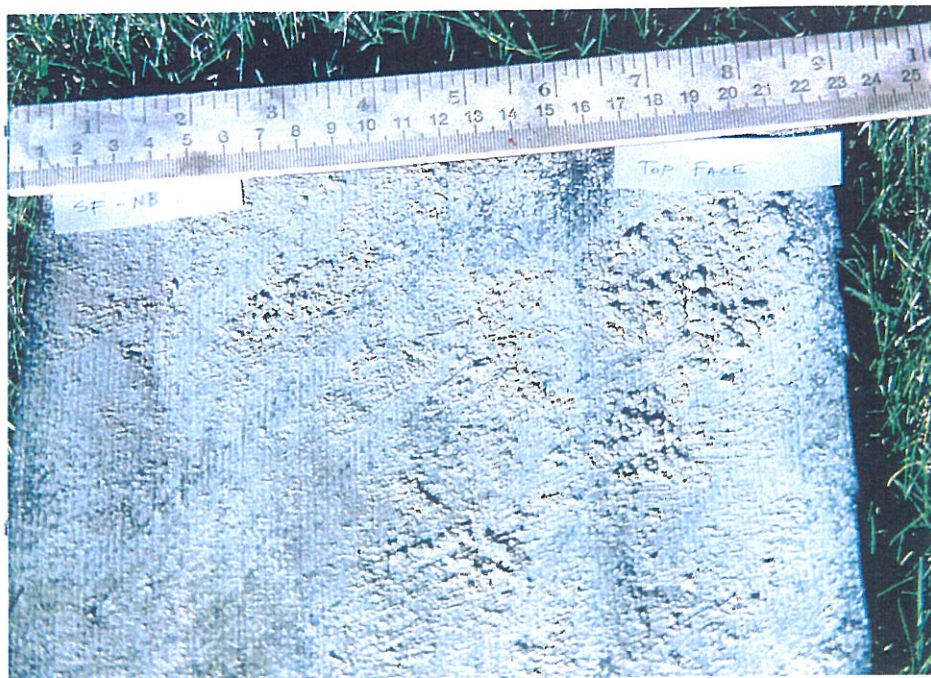
Figure 5.23 - Top of SF-NB wide width specimen, lab. photo. Soil on geotextile is dry.

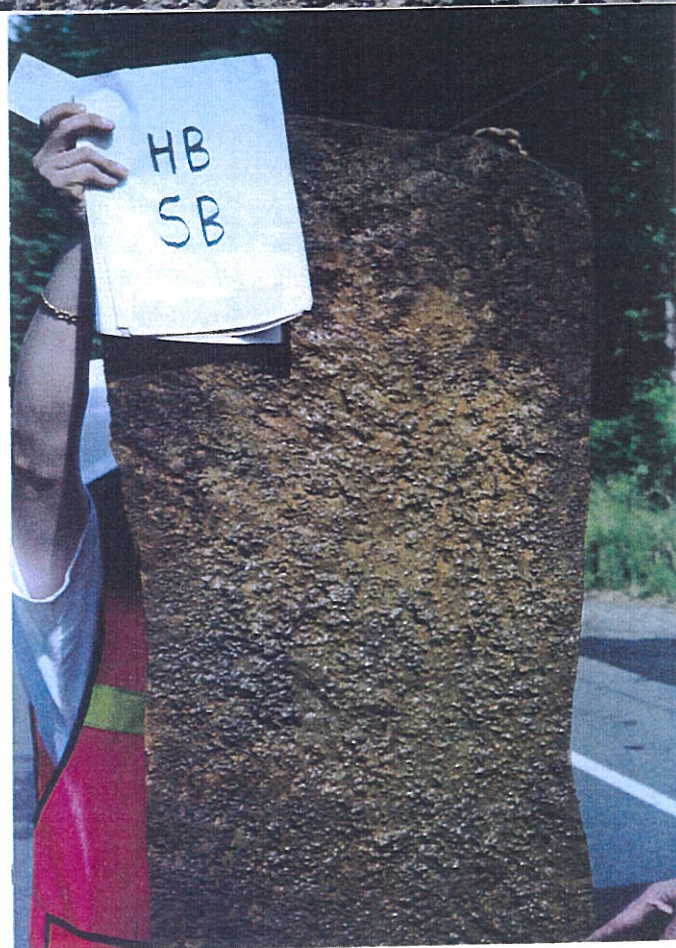
Figure 5.24 (top) - HB-SB geotextile before removal, with corner peeled back. Figure 5.25 (bottom) - HB-SB geotextile after removal, top face shown.

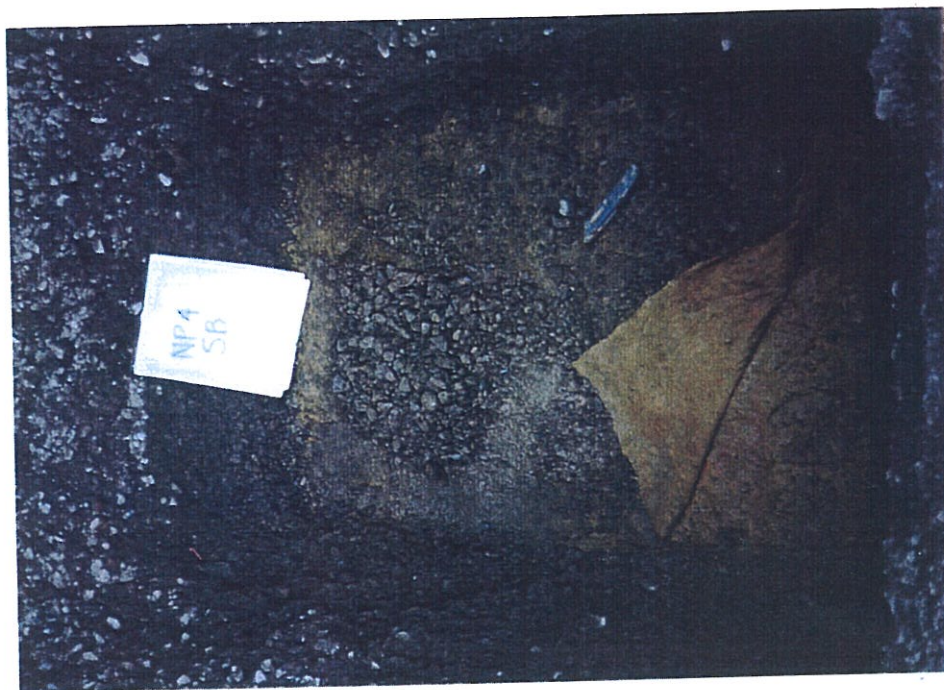
Figure 5.27 - NP4-SB geotextile before removal, with corner peeled back.

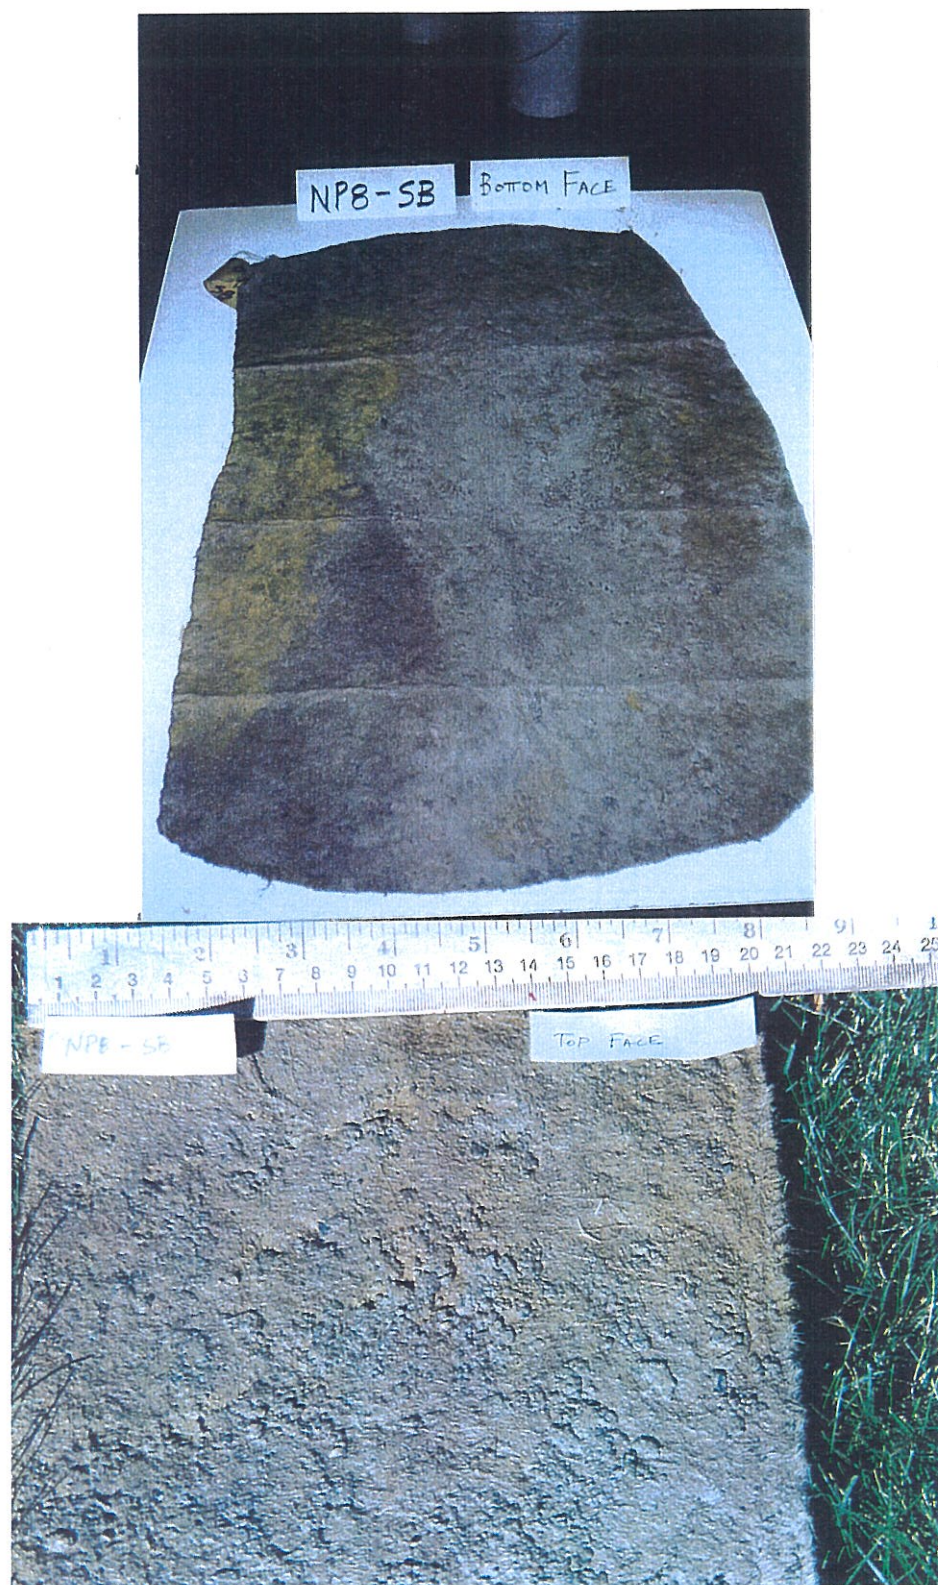
Figure 5.36 (top) - Bottom of NP8-SB geotextile, laboratory photograph showing multicolored iron staining. Figure 5.37 (bottom) - Top face of NP8-SB wide width specimen, laboratory photograph showing caking.

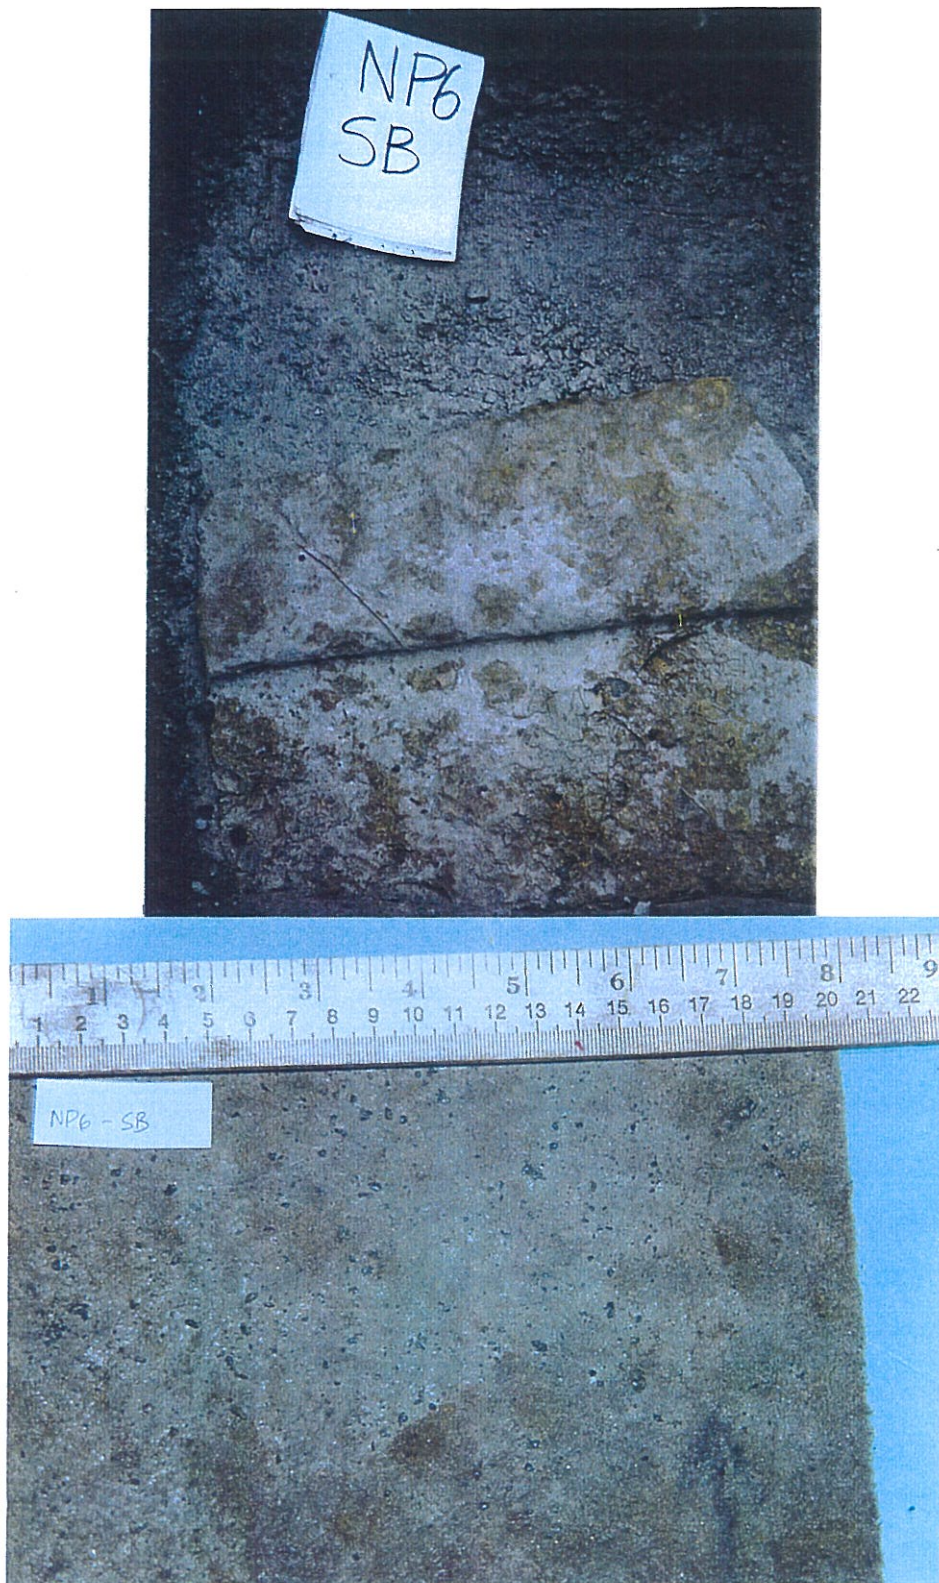
Figure 5.38 (top) - NP6-SB geotextile before removal, with corner peeled back.  
Figure 5.39 (bottom) - Bottom of NP6-SB geotextile, laboratory photograph showing iron staining and clogging.
